# Manhole Inspection Summary

Manhole # S25CC1004MH

Insp Date: **1/26/07 8:52 AM**

**Location** Address: **1206 UNION AVE**

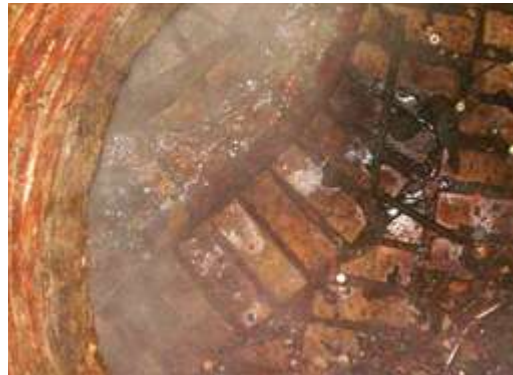
Top View

**Steps** Count: **6** Missing: **0** ☒ **Corroded**

**Surcharge** ☒ **Evidence Of Surcharge** Depth: **1** (ft.) ☐ Active Surcharge Present

Corroded steps. Evidence of surcharge - Bench debris.

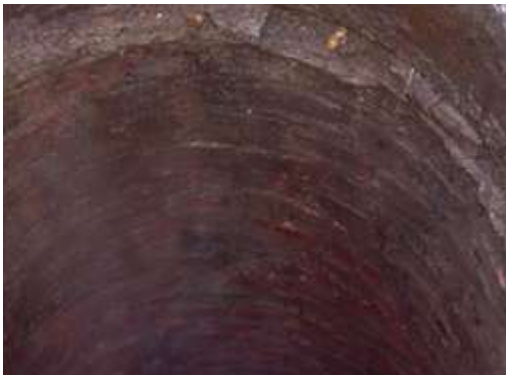
Defect

☒ **Leaks**

Condition: ☐ Sound ☐ Cracked ☐ Root Intrusion ☐ Loose Brick ☒ **Deteriorated**

Infiltration: ☐ None ☒ **Joint** ☐ Cracks ☐ Mortar ☐ Roots ☒ **Wall**

Frame leaks. Adjustment deterioration and infiltration.

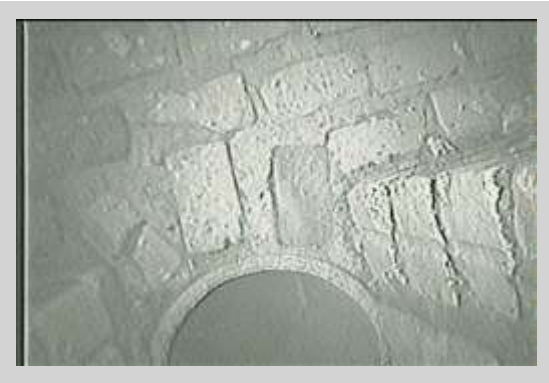
### 8 in. Circular Gravity Sewer Pipe Out @ 12 O'Clock

Invert Depth: **11.78** (ft.) Flow Characteristics: **Fast**

Infiltration: **None** Pipe Seal Cond: **Unknown**

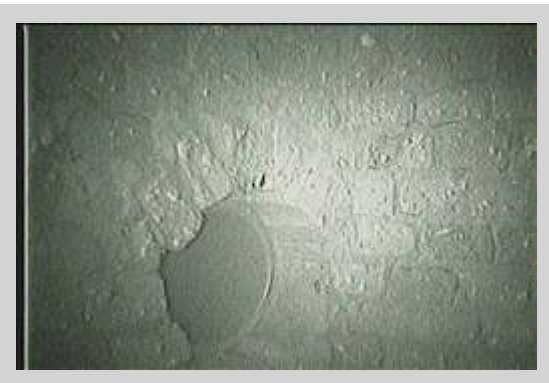
### 8 in. Circular Gravity Sewer Pipe In @ 8 O'Clock

Invert Depth: **9.80** (ft.) Flow Characteristics: **Fast**

Infiltration: **None** Pipe Seal Cond: **Unknown**

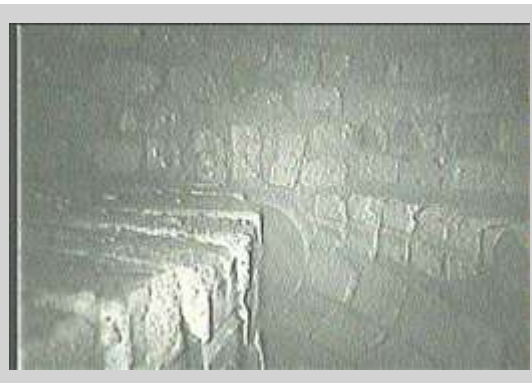
### Drop In @ 8 O'Clock

Condition: ☐ Sound ☐ Cracked ☐ Root Intrusion ☐ Loose Brick ☒ **Deteriorated**

Infiltration: ☐ None ☐ Joint ☐ Cracks ☒ **Mortar** ☐ Roots ☐ Wall

Condition: ☐ Sound ☐ Cracked ☐ Root Intrusion ☒ **Deteriorated** ☐ Leaks ☐ Debris

Barrel deterioration and infiltration. Bench and Channel deterioration.

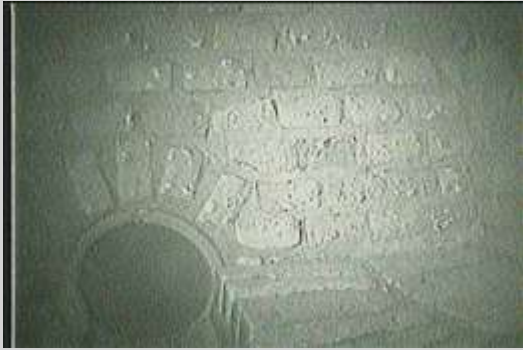
Pipe In @ 9 O'Clock

Invert Depth: **11.72** (ft.) Flow Characteristics: **Fast**

Infiltration: **None**

Connects To: **Dead End**
